HO-123

Clark Family Farm  
15081 Roxbury Road  
Roxbury Mills vicinity

## Maryland Inventory of Historic Properties Form

historic Clark Family Farm  
other George Chase Brick House

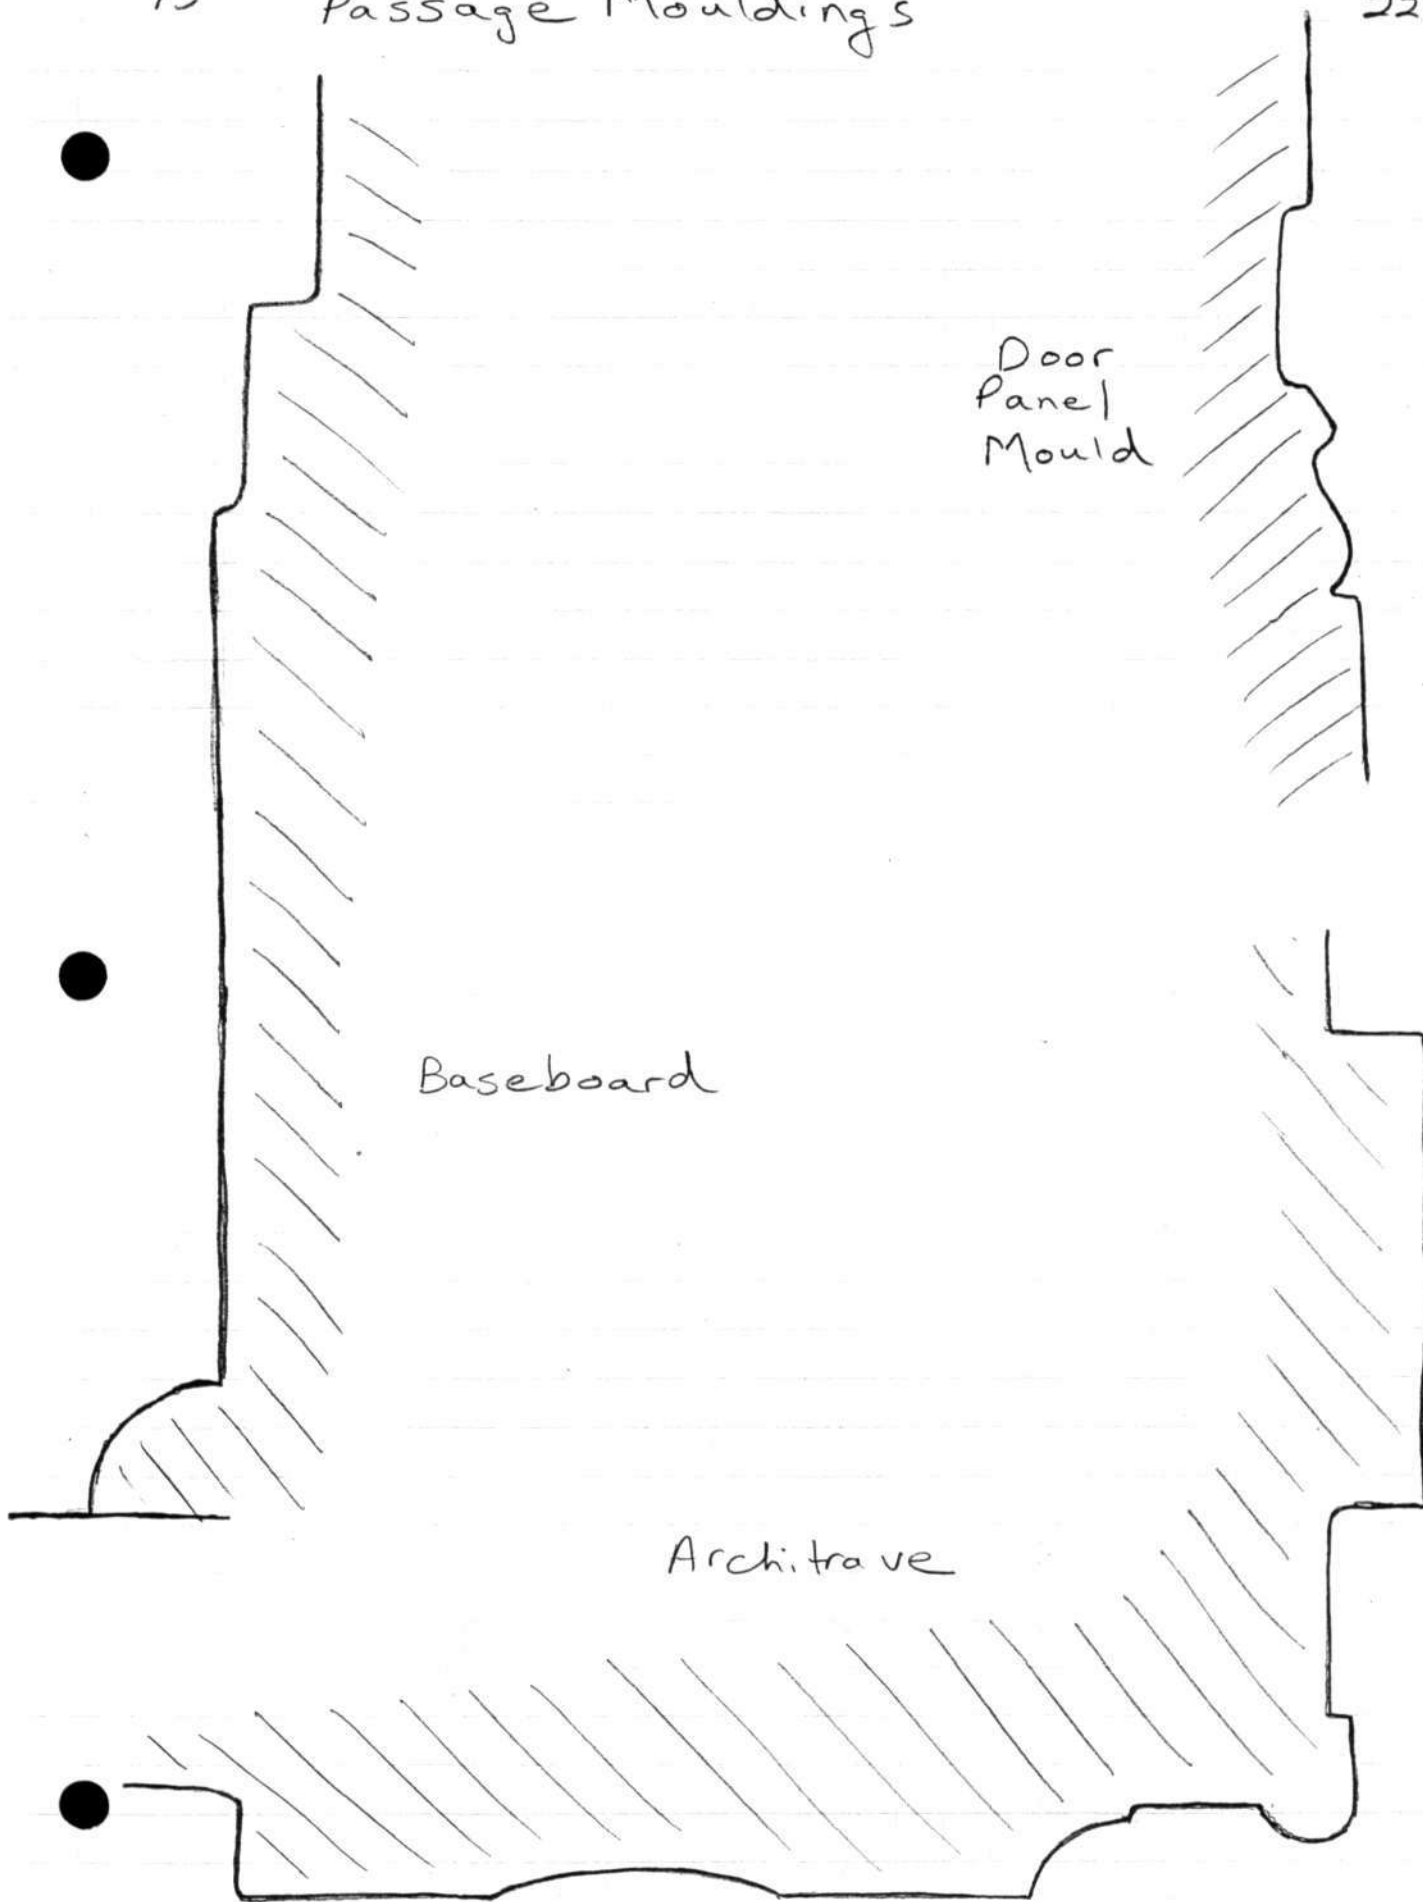
East  
Room  
Mantel  
Bed  
Mould

The east room flooring matches the passage, and the baseboard has a quirked ogee and bevel. The architrave has a backband with a rounded outer edge and a quirked Greek ovolo. There is a broken field with a quirked Greek ovolo at the break, and a raised bead on the inner edge. The corners of the architrave are curved rather than mitered. The east room has a four-panel door with sunken fields and quirked ogee and bevel panel moulds. It has through tenons with wedges, with no pins visible. The door is hung on cast iron butt hinges with two knuckles and has a cast iron rim lock with beveled sides and a metal knob. The windows have 10-inch by 16-inch lights with ovolo muntins and parting beads. The sash are mortised and tenoned and pinned at the corners and the muntins are pinned to the rails. The openings have plain straight board jambs. The first-story window jambs and sills all have 3 3/8-inch boards added between the original boards and the architrave. This same treatment is done on the second story north windows only. There are spring latches and thick windowsills with an ogee moulding on them. The moulding beneath the sill matches the architrave in this room. There is a fireplace centered on the east elevation, and it has a new hearth of raised concrete. There are splayed brick jambs, and the parging has been removed from the surround. There is a wood mantel with tapered pilasters and reverse tapered capitals that are like a stylized cushion capital. The mantel has a plain frieze with a segmental arch on the bottom and plain impost blocks. The bed mould has an ogee, and there is an ovolo mould on the front of the shelf. It appears that the sides of the mantelshelf projected beyond the fireplace end walls, but were cut off at some point.

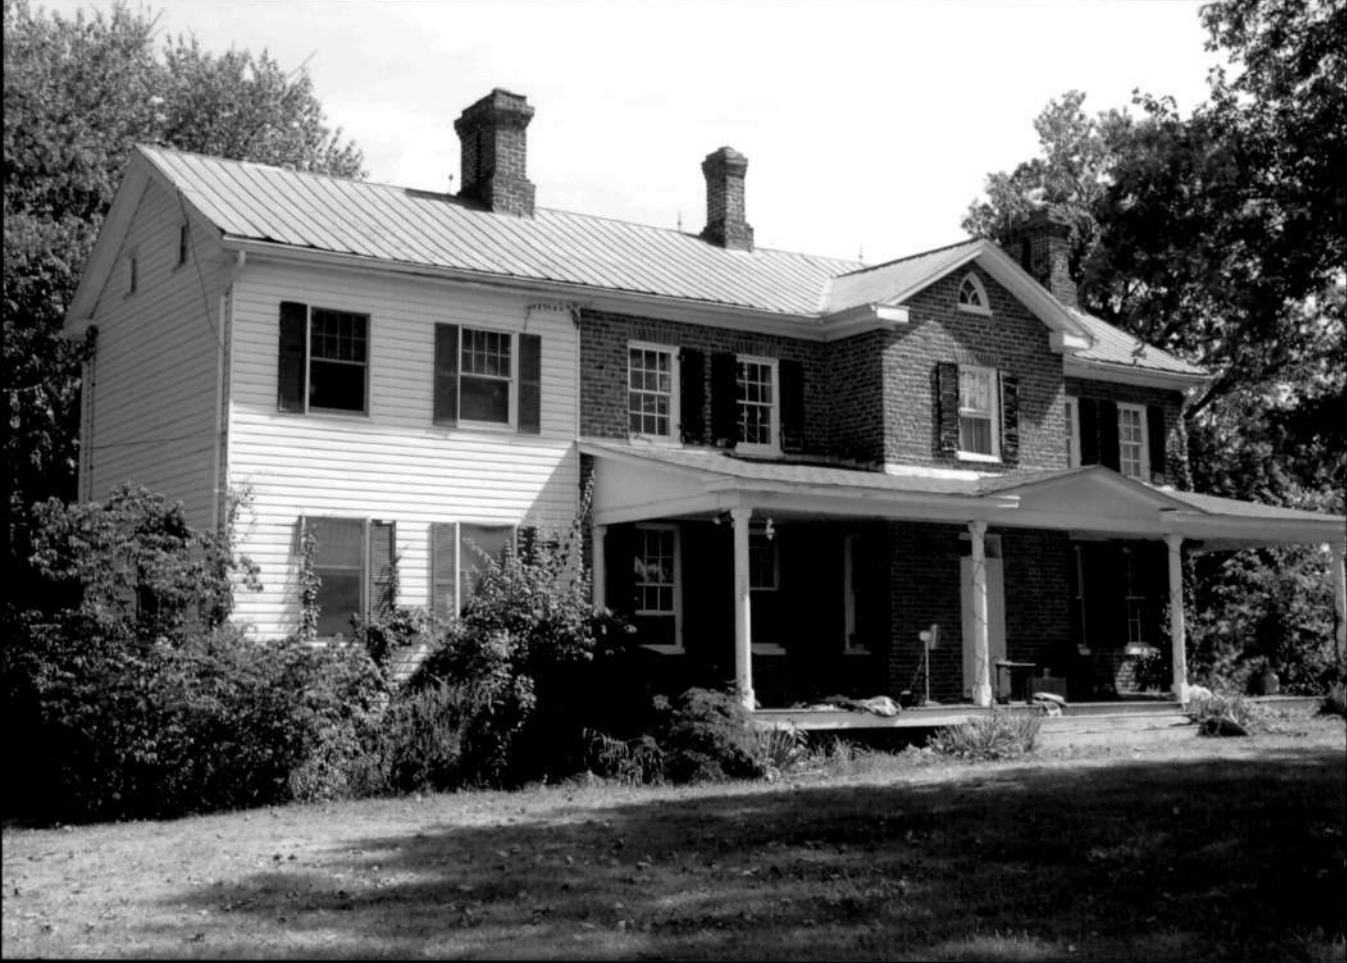
1/16

House, west and south elevations

The house is a two-story, five-bay by two-bay structure of 5 to 1 common bond brick with poor quality re-pointing, and it has a rubble stone foundation and a gable roof with an east-west ridge and inverted-V-seam metal roofing. There is a projecting center bay on the south elevation with a gable. There is a two-story, two-bay by two-bay frame addition on the west end of the house, with a rubble stone foundation, aluminum siding, and a gable roof with an east-west ridge and inverted-V-seam metal roofing. There is also a one-story rubble stone wing on the north, attached to both the frame addition and the brick main block. This wing is one bay by one bay and has a gable roof of inverted-V-seam metal with a north-south ridge.

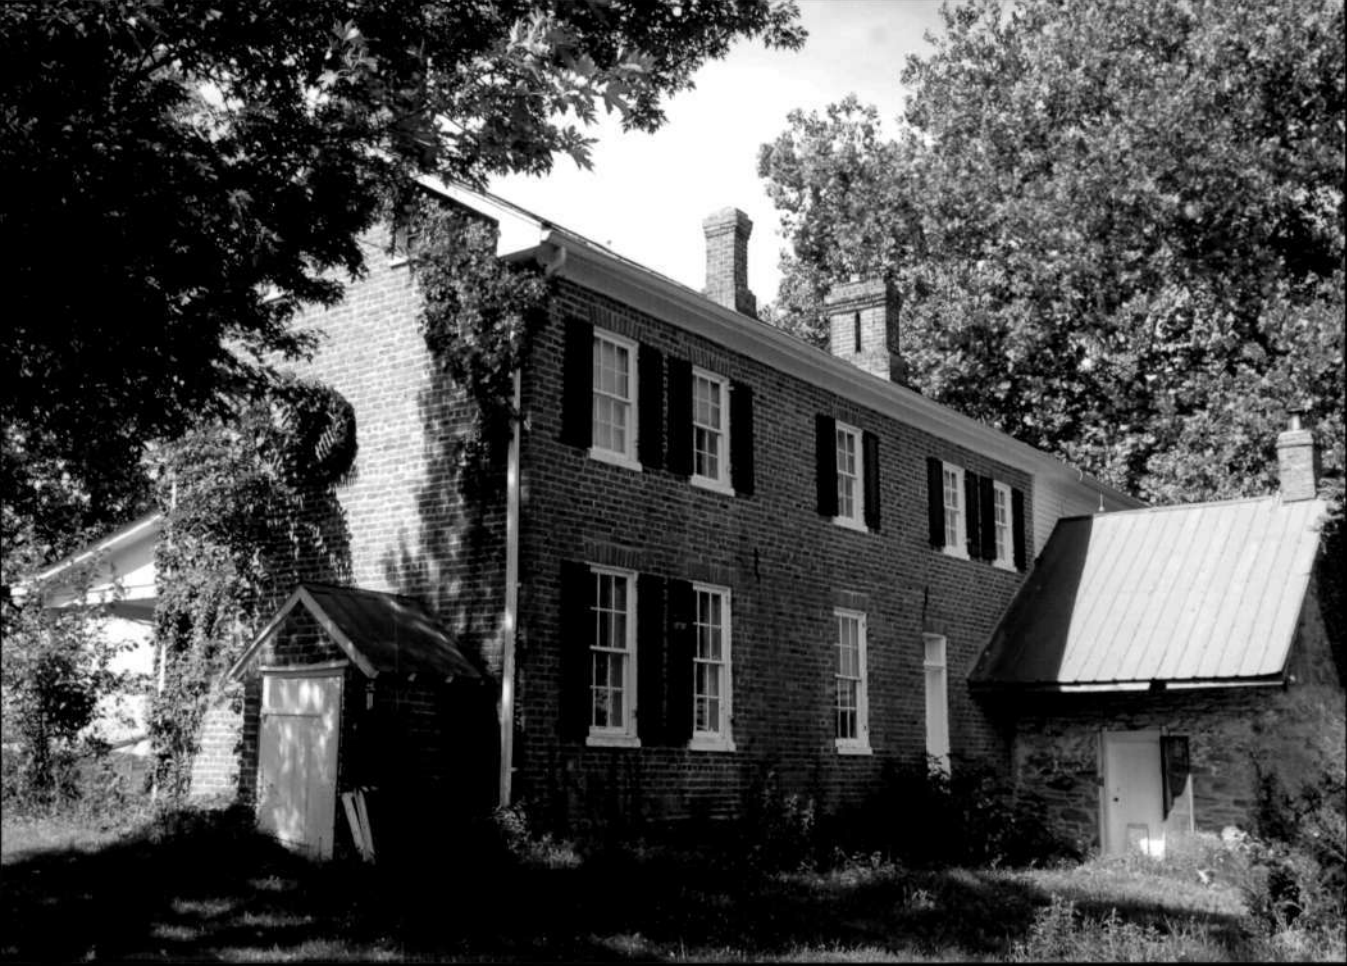
2/16

House, east and north elevations

The east elevation of the main block has a projecting brick cellar entrance with a gabled roof that has an east-west ridge and inverted-V-seam metal roofing in the north bay of the first story. This entranceway has open eaves and a vertical-board door on tapered strap hinges. There is no opening in the south bay and no opening on the second story. The gable end has two four-light sash with wood sills. The north elevation of the main block has a three-light sash behind horizontal wood bars in the center bay of the foundation, and this opening has a splayed jack arch. The first story has typical six-over-six sash in the east, east-center, and center bays. The center bay is unaltered. The west-center bay has a door that originally had six panels in a bullnose frame with a three-light transom, a concrete sill, and a splayed brick jack arch. Four of the panels were cut out and glazed. The small frieze panels are set in the center. The west bay has no opening, and there never was one here. There are two "S" tie rod endplates between the first and second stories. The second story has five typical six-over-six sash and the cornice bed mould appears to be an ovolo.

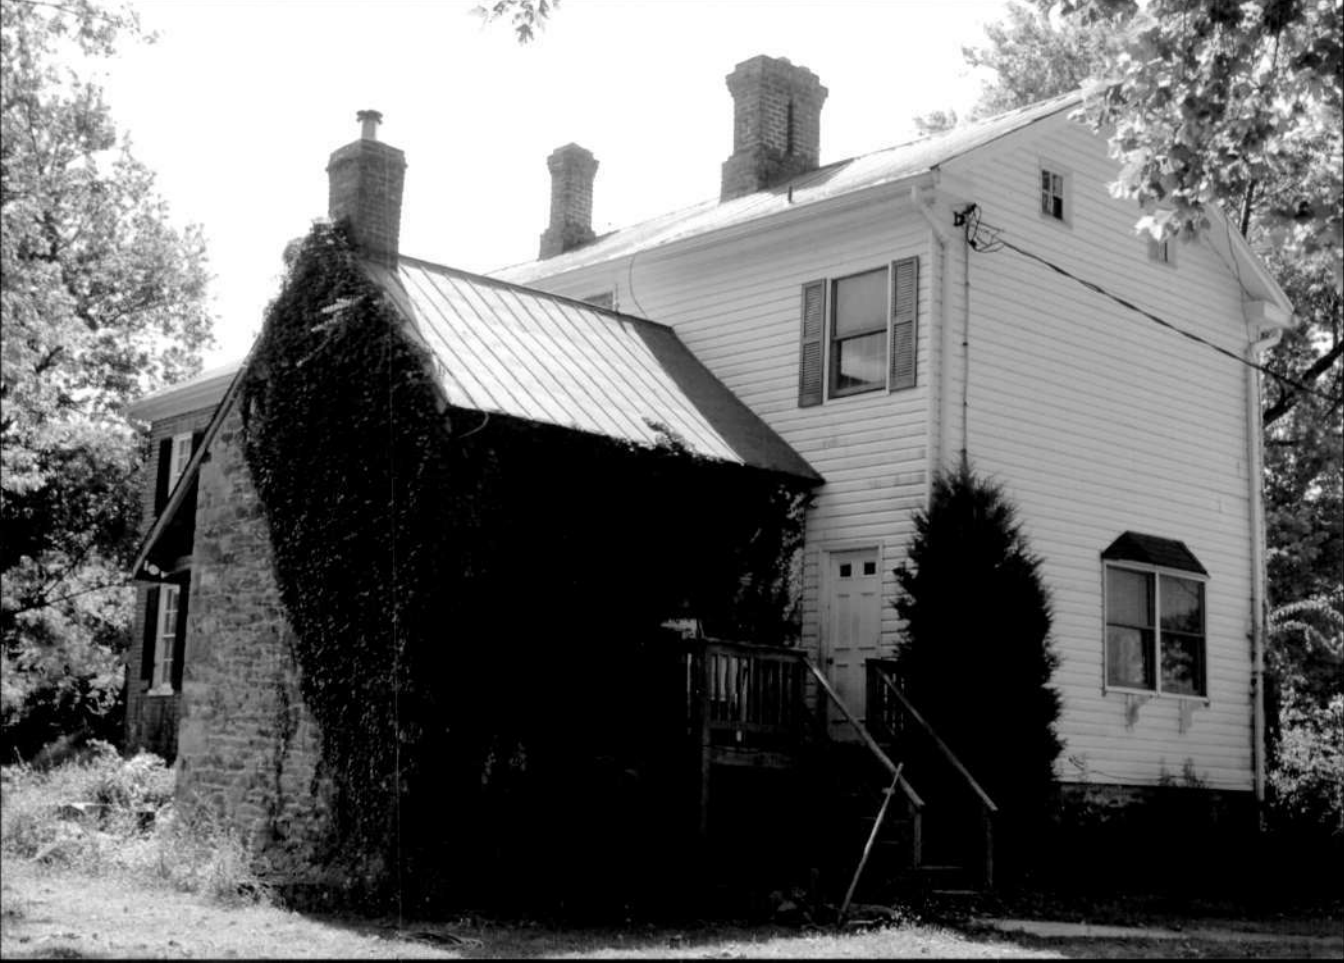
3/16

House, north and west elevations

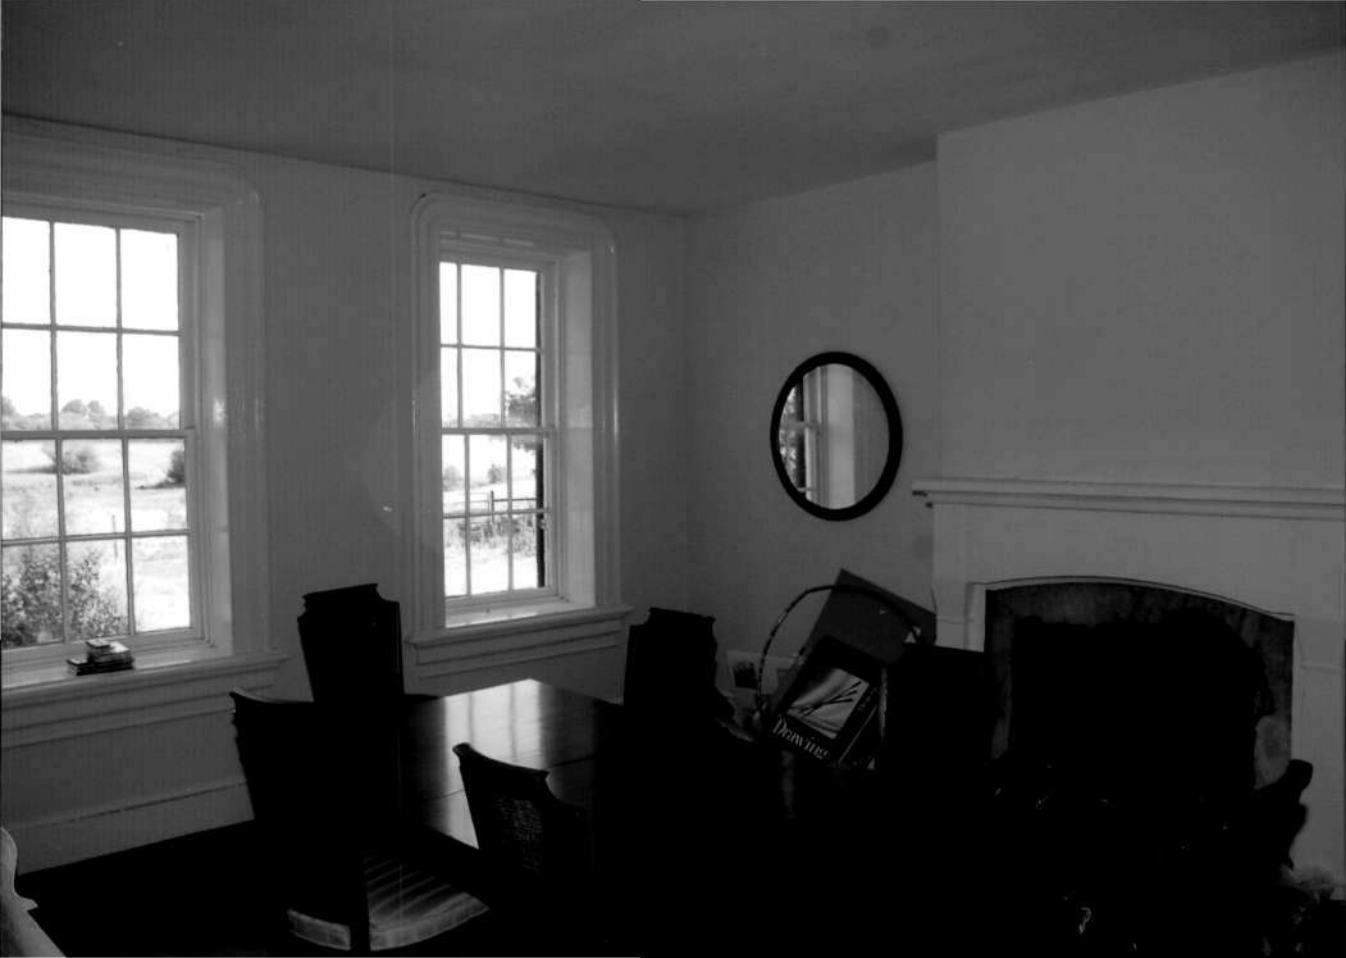
4/16

House, east room, view, northeast

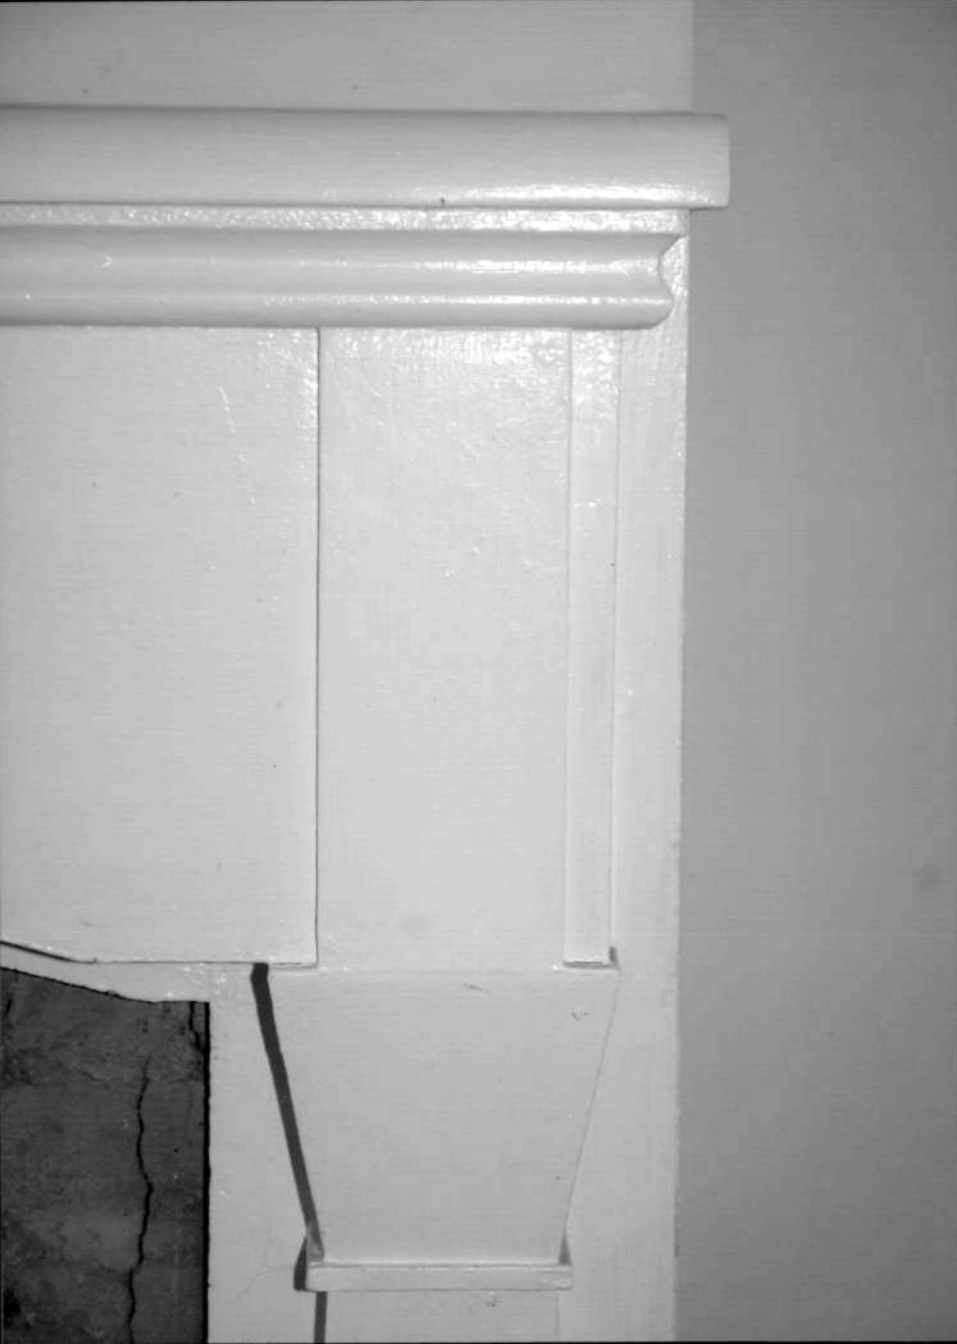
5/16

House, east room, mantel detail

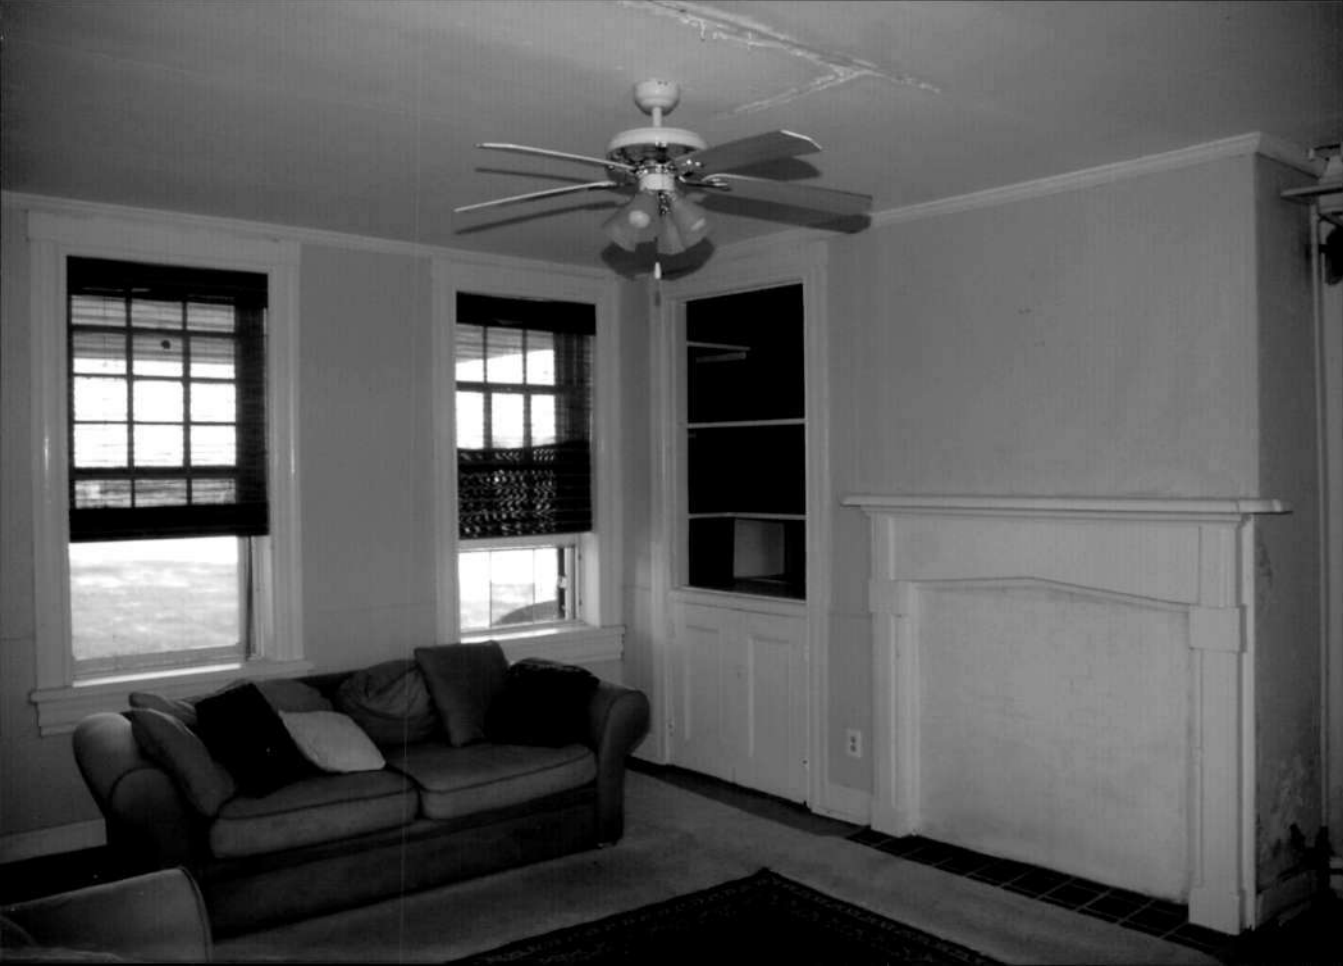
6/16

House, west room, view southwest.

The west room flooring, baseboard, and architrave match the passage, while the windows and doors match the east room. The east elevation door that is set to the north, the north elevation door, and the west elevation door all have architrave that is mitered, with no corner blocks, however. The east door that is set to the north has four panels with sunken fields and no panel moulds. It has through tenons with wedges and no evidence of pins. There are new hinges and a plain cast iron rim lock with a metal knob. The north door bottom panels have sunken fields and quirked ogee and bevel panel moulds. The transom is mortised and tenoned and pinned at the corners. The west door matches the east elevation door that is set to the north, and has a porcelain knob. The east door that is set to the south has a plain cast iron rim lock with brass knobs, but this lock is not original to the door. There is a fireplace centered on the west wall, with a quarry tile hearth, and the opening is closed off. It has a wood mantel with plain piers that have an applied rounded pilaster strip. There is a plain frieze with a triangular arch in the bottom of it, and the imposts match the pilasters. The bed mould has an ogee above the cavetto. There is a cavetto mould on the edge of the mantelshelf, and this shelf has quadrant corners. To the south of the fireplace is a built-in cupboard that is missing its top pair of doors. The two bottom doors have one panel each that is sunken and flat and has quirked Greek ovolo panel moulds. These doors are hung on cast iron hinges with two knuckles. The back of the cupboard has been cut through to create a pass-through into the west wing.

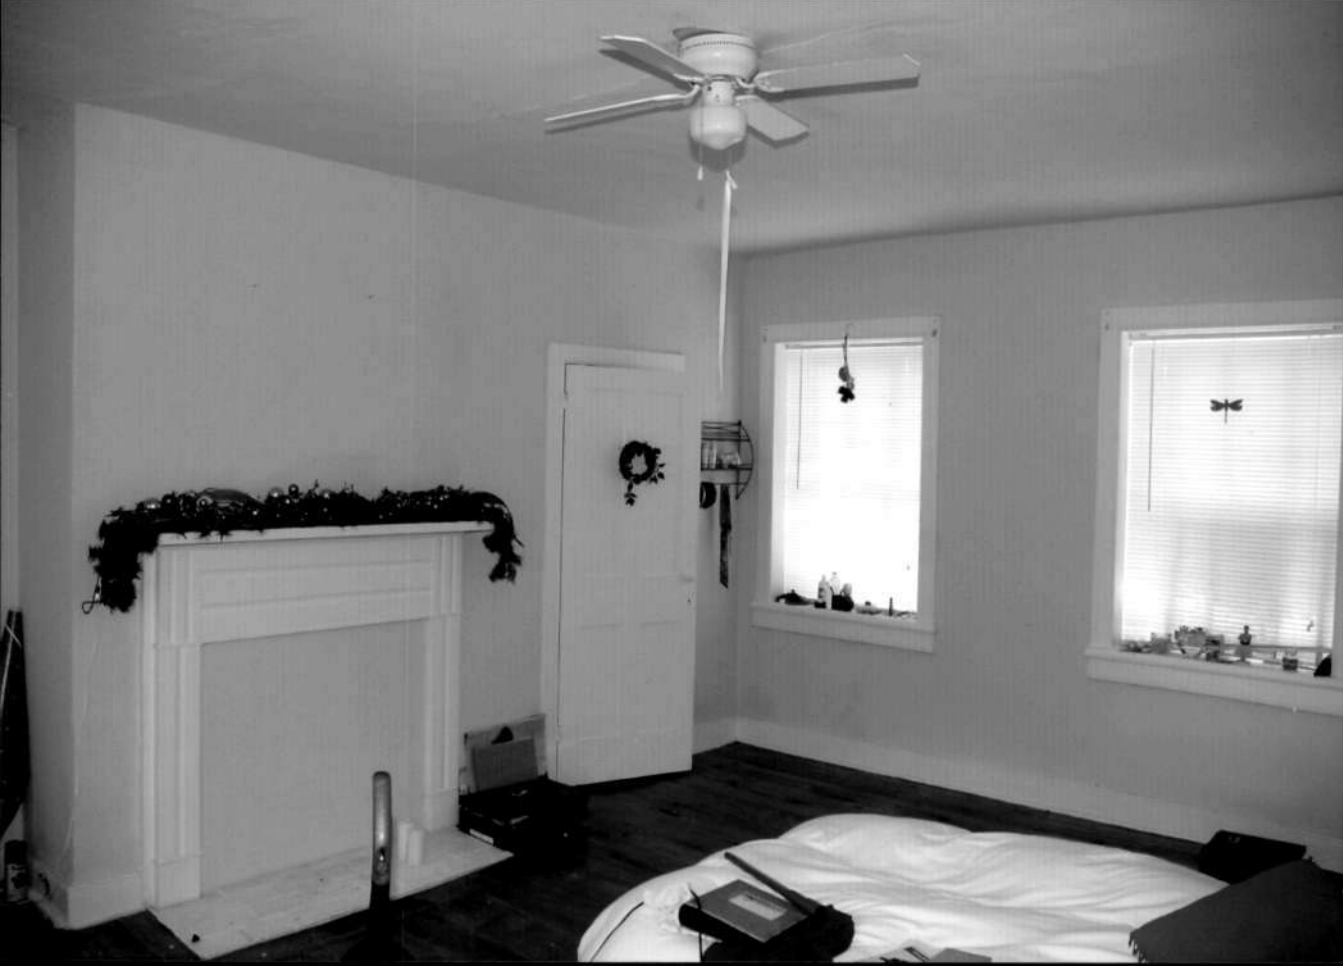
7/16

House, east chamber, view southeast

The east chamber flooring, baseboard, architrave, and windows match the passage. There is a fireplace that is centered on the east elevation and has been closed off. It has a brick hearth and a wood mantel with pilaster strips that have a shallow depression in the center. The imposts above have two shallow depressions, and the frieze has two shallow horizontal depressions. The bed mould is a cavetto, and there is a plain shelf that is rounded at the corners. To the south of the fireplace is a built-in closet with typical architrave for this room and a four-panel door that has sunken, flat panels that are beveled on the back side. This door is mortised and tenoned and pinned. It has a small cabinet lock on the interior side that appears to be original, and a wooden door pull. The south-center chamber flooring, baseboard, architrave, and window match that in the passage. The walls are now covered with modern paneling.

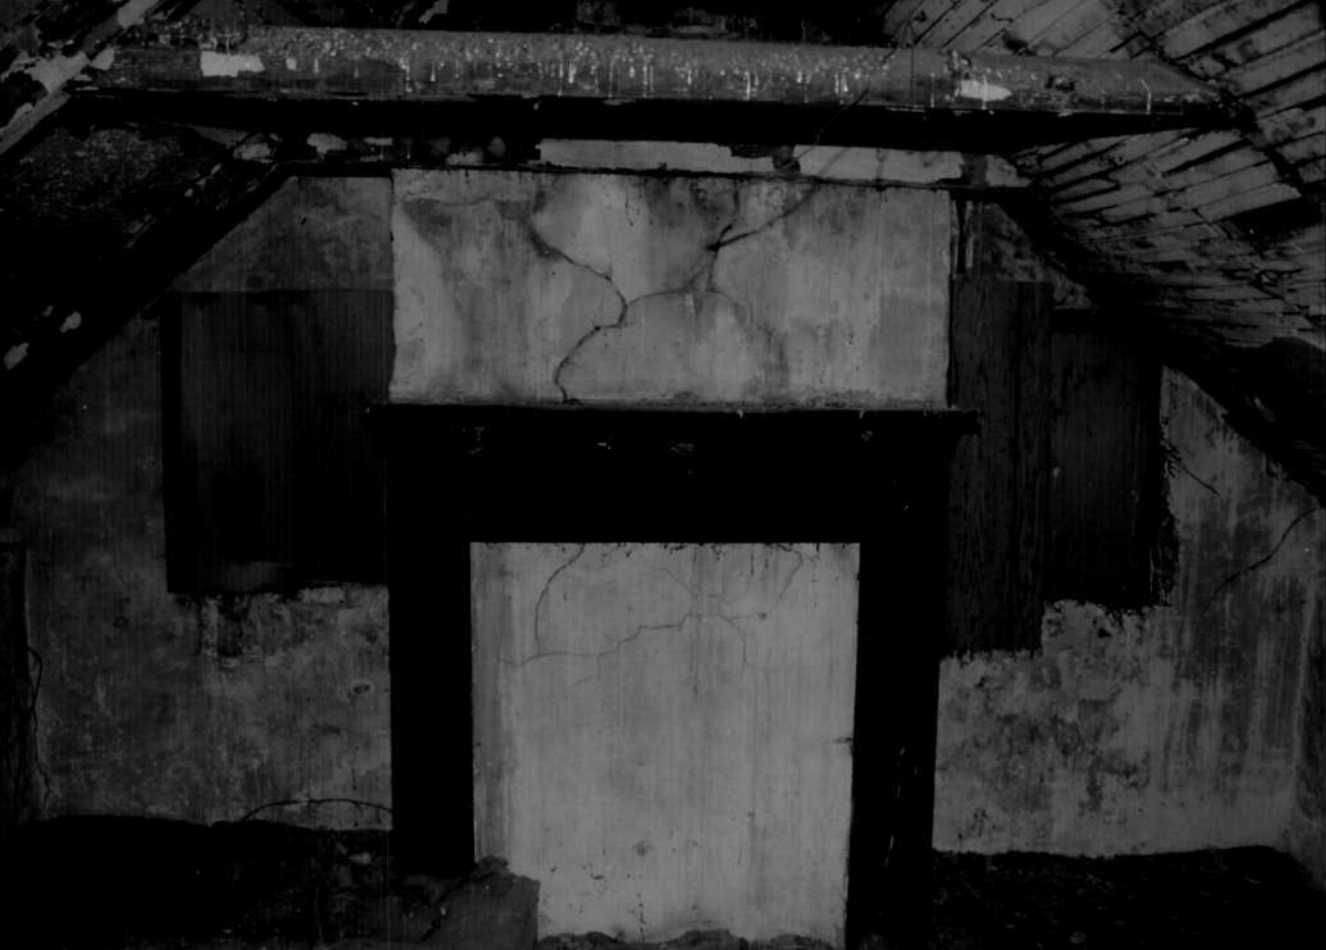
8/16

House, stone ell second story,  
view north

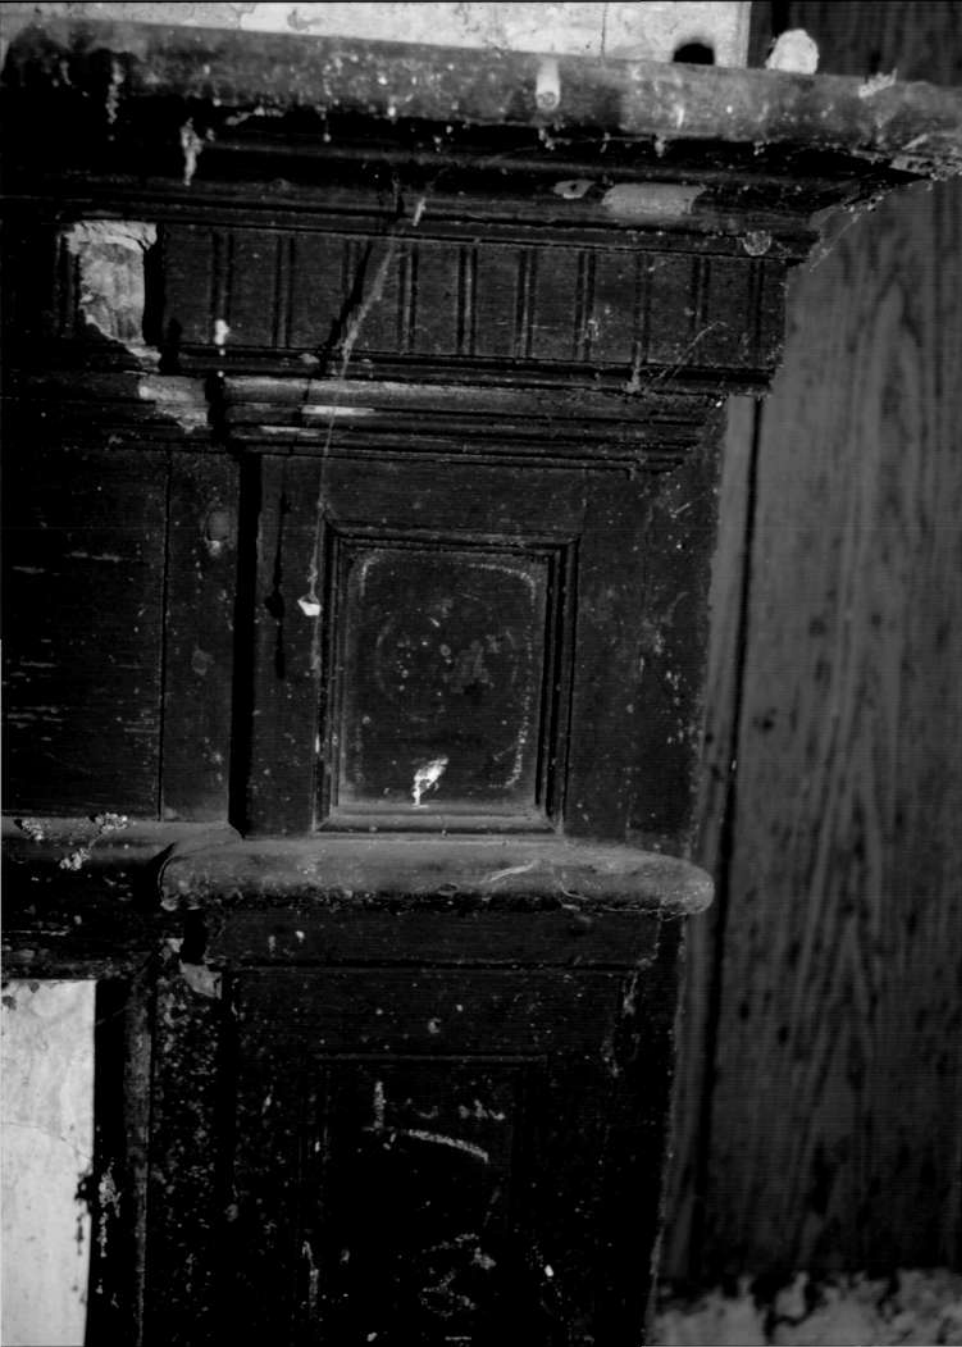
9/16

House, stone ell second story,  
mantel detail

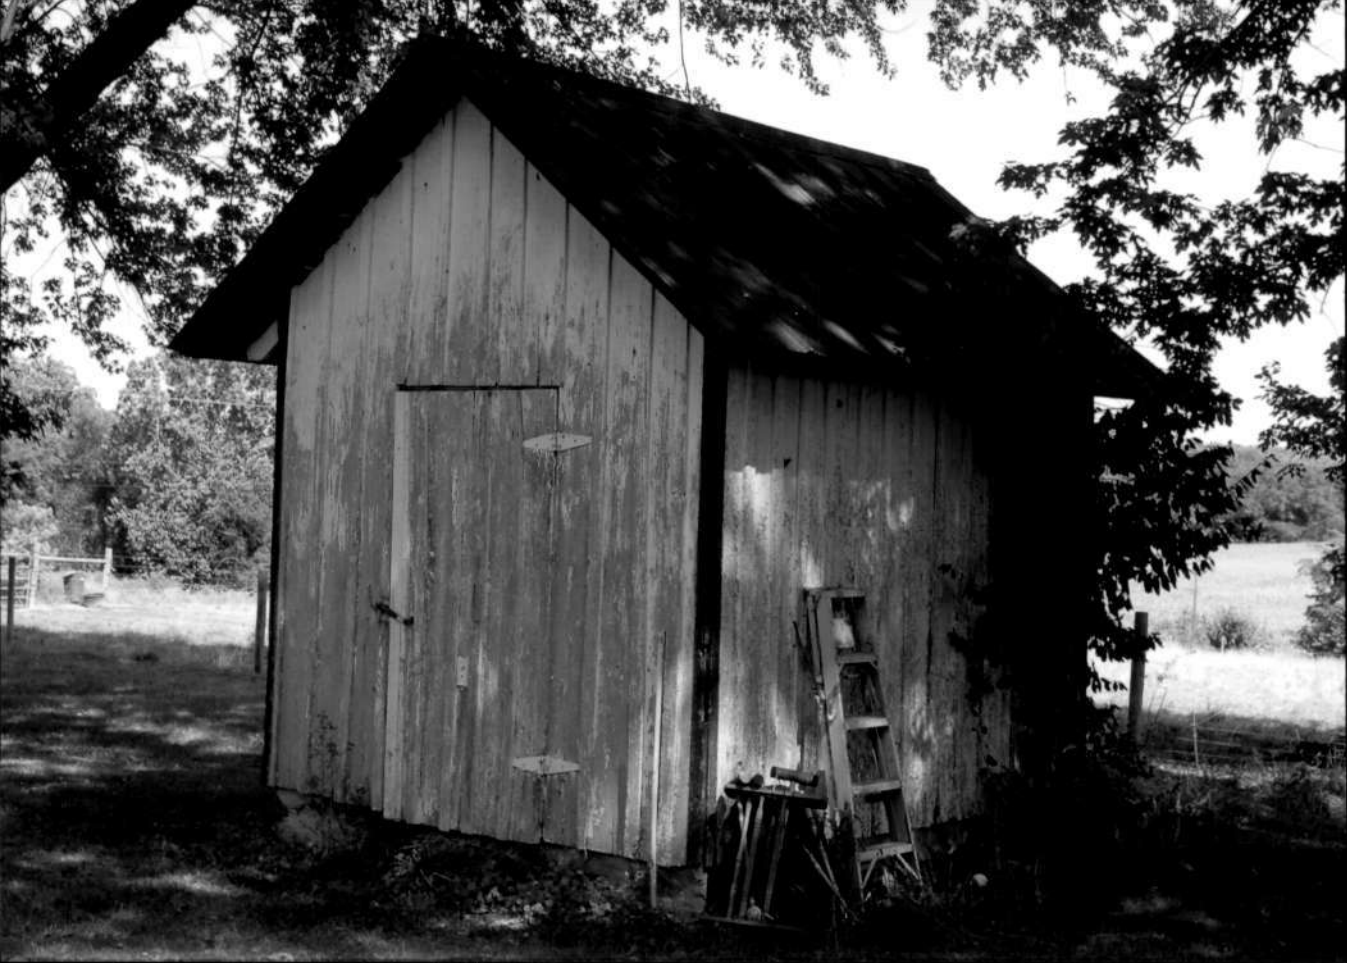
10/16

Shed, south and east elevations

About 40 feet northwest of the stone wing is a one-story, one-bay by one-bay frame shed with a rubble stone foundation, board-and-batten siding and a gable roof with inverted V-seam metal and a north-south ridge. The south elevation has a board-and-batten door with a wrought hasp, and there are no openings on the east, west, or north elevations. The building has open eaves with circular-sawn 2 by 4 rafters. It is constructed with 6 by 6 posts and sills, 4 by 6 plates, and 4 by 4 braces and middle horizontals, all of which are circular-sawn and wire-nailed. The rafters are mitered at the ridge and support shingle lath.

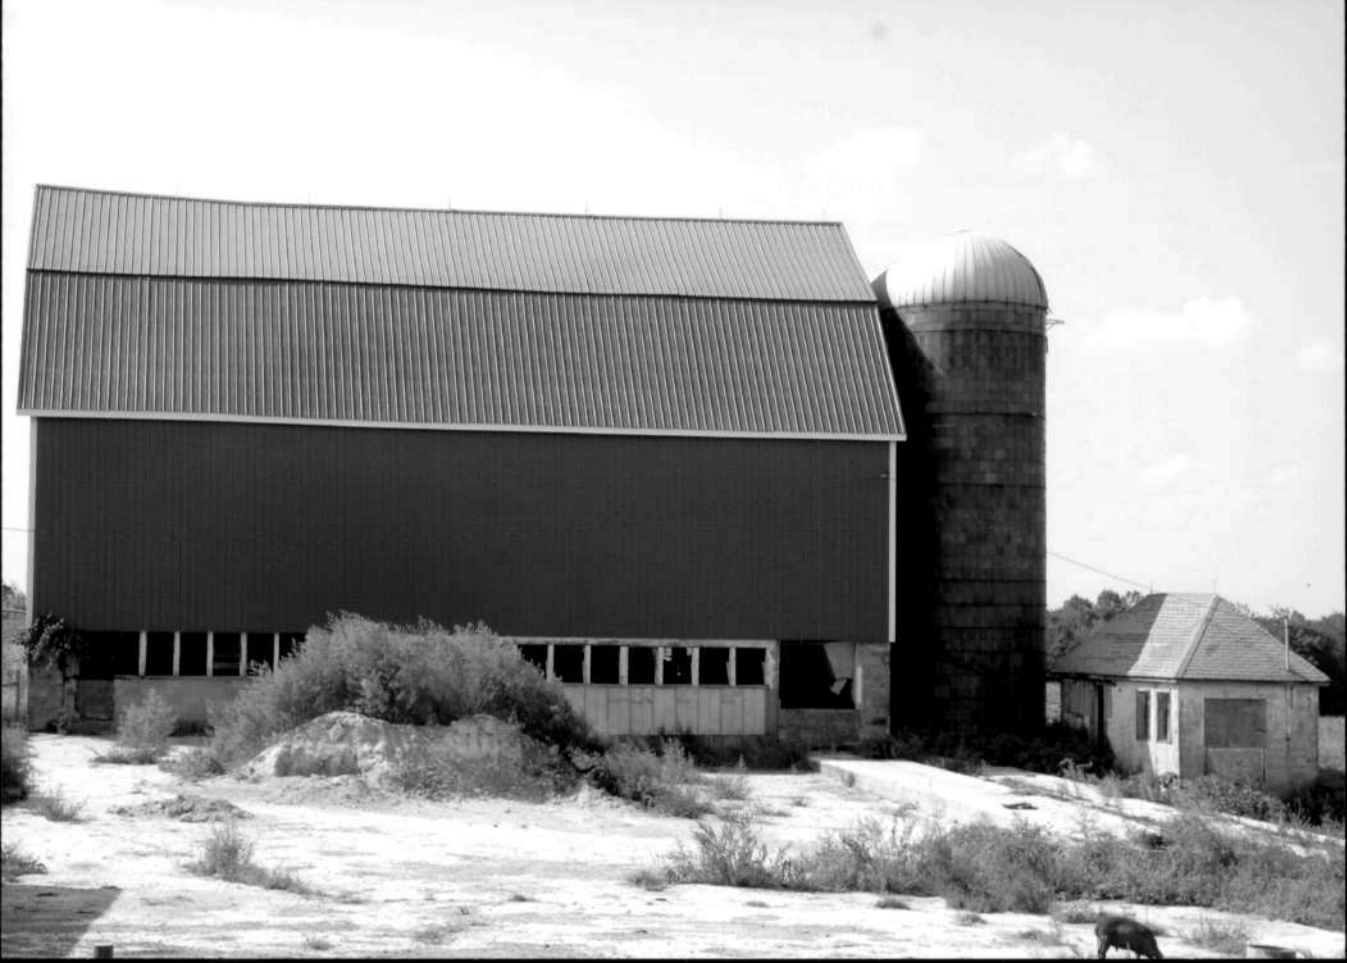
11/16

Barn, east elevation

There is a banked barn located about 60 feet northwest of the stable, with a forebay that faces east and a ramp on the west. It has a stone lower story that has raised-bead pointing, and there is inverted-V-seam metal on the upper story and the roof. The roof has a gambrel with a north-south ridge. On the east elevation the lower story has CMU infill and had doors on each end in the infill, with six windows to the south of a center door and 11 windows to the north of the center door. The sash are now gone. If there were any upper story openings, they are now covered on all sides by the metal siding. On the south elevation, the lower story has two windows with four-light steel sash. There is a terra cotta tile silo on the north elevation, consisting of paired silos with an aluminum dome cap. The west elevation has a pair of large doors on rollers in the center, with a modern flush door to the south of them.

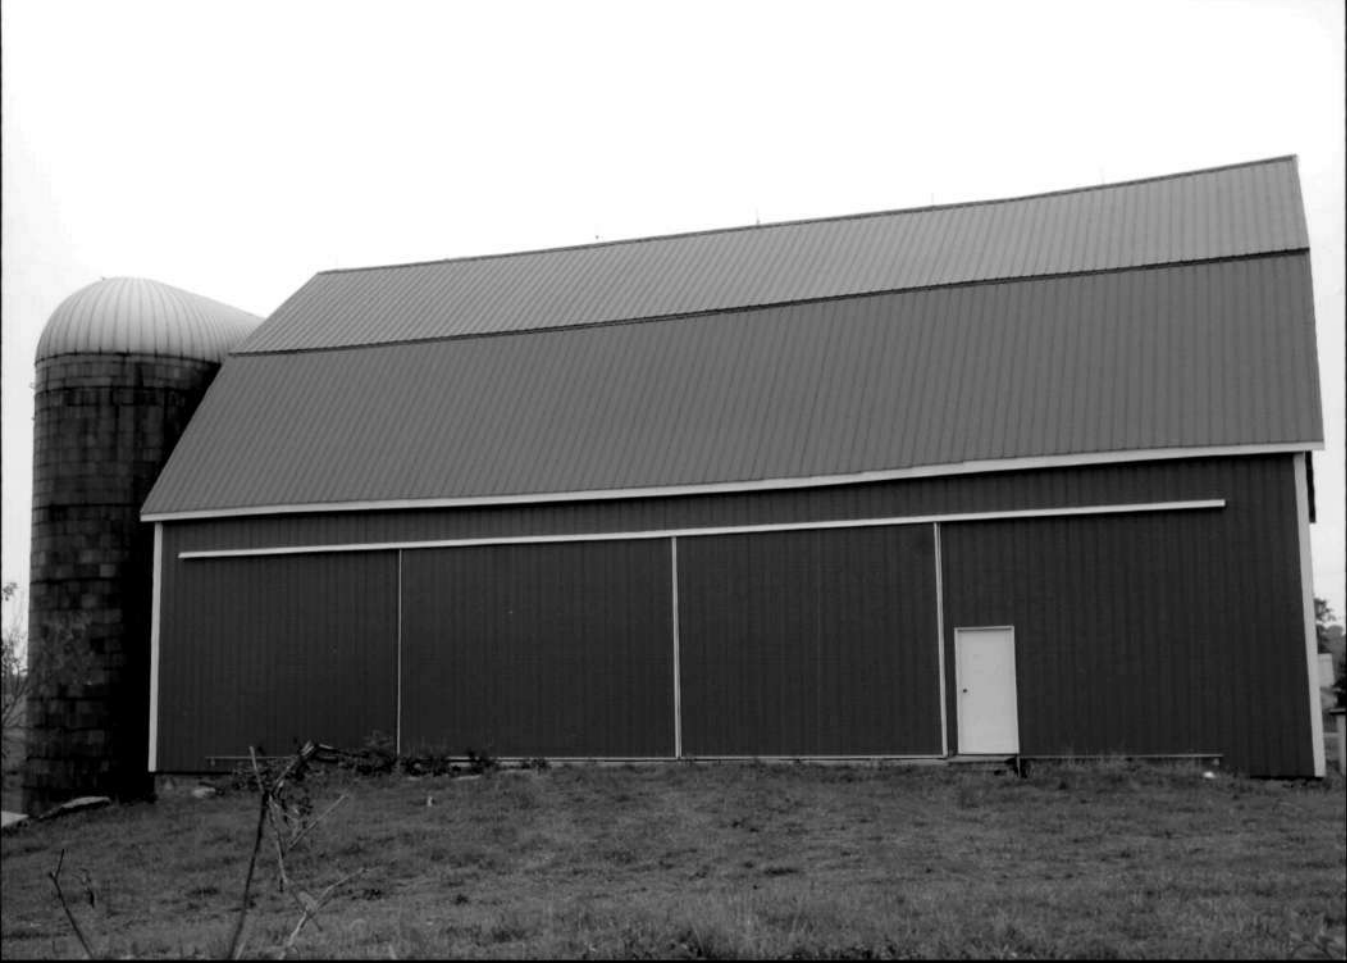
2/22/08 Ben Short, photographer  
Barn, west elevation  
12/16

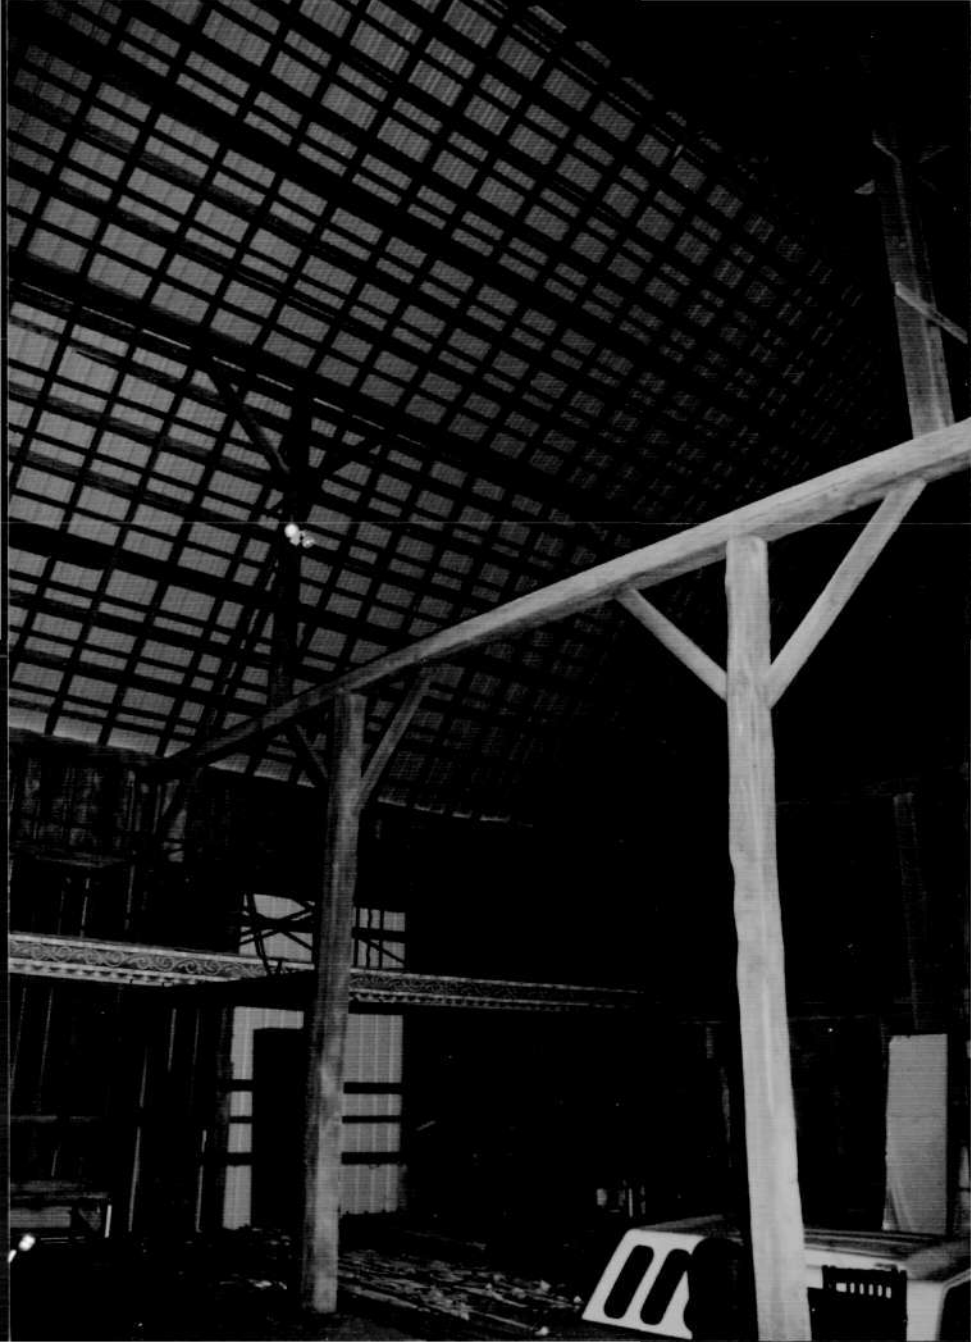
13/16

Barn, interior, view northeast

beams, and a board ceiling. In the northeast corner is a wood hopper and chute. The upper story has two center threshing floors with a granary/chaff room in the northeast, northwest, southeast and south-center. The barn is constructed with a circular-sawn heavy timber mortised and tenoned and pegged frame. There are purlins at the gambrel ridge, with posts beneath them and high down braces on the outer sides of these posts, resting on the dropped girts of the outer bays. The dropped top girt has been cut out, but the center girt and center post remain. Numerous braces have been removed, no doubt to facilitate maneuvering modern machinery inside the barn. Most of the joints have iron plates across them, and these were probably added. The plates have half-lap scarf joints with four face pegs. There is a hay track in the ridge.
